Roof Fixings to Interlocking Tile Roof

All Pictures are taken from G. R. Edwardes Ltd own PV Jobs and are an example of Quality Workmanship. All work is carried out by Employed staff which are highly trained and experienced professionals

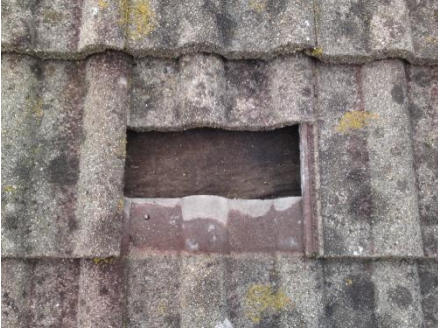
Picture showing the tile being pushed up.

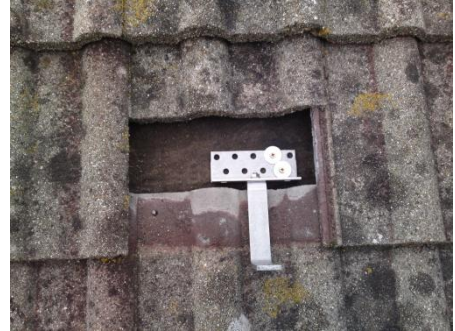
Picture showing the roof anchor being fixed to the common rafter (Truss).

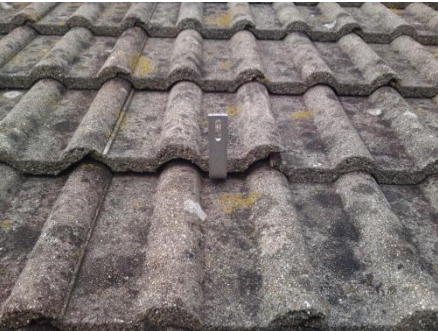
Picture showing the finished look of the tiles after the roof anchor has been installed.

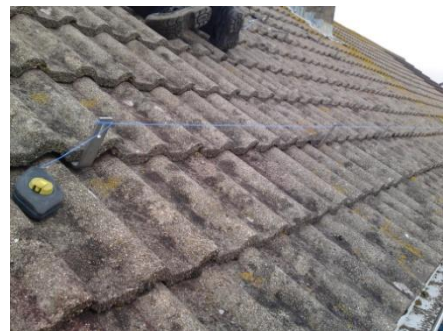
Picture showing the levelling of the roof anchors.

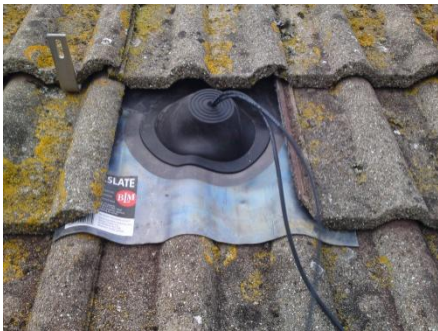
Picture showing method of cable entry. (This is eventually behind the panels).

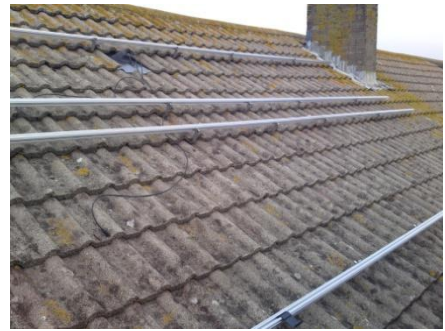
Picture showing the finished rails and cable entry. (Now ready for the panels)

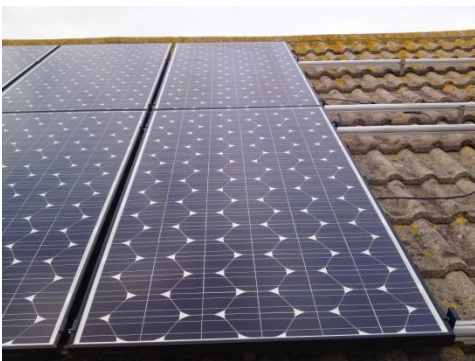
Picture showing the fixing of the Panels to the rails. (These are Sanyo HIT 240)

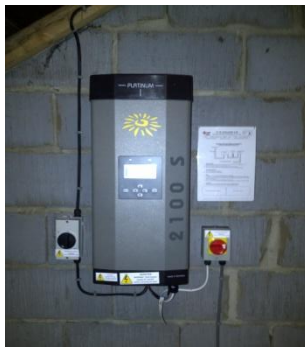
Picture showing the Inverter installed. Safety notices and Isolators.

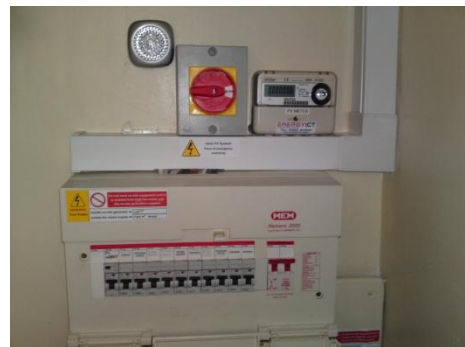
Picture showing the Consumer unit, Main Isolator and PV Meter. Another tidy job!
